# ***INITIAL STUDY - APPENDICES***

***Volume 2 of 2***

## ***Mammoth View***

***Viewpoint Road  
Mammoth Lakes, CA 93546***

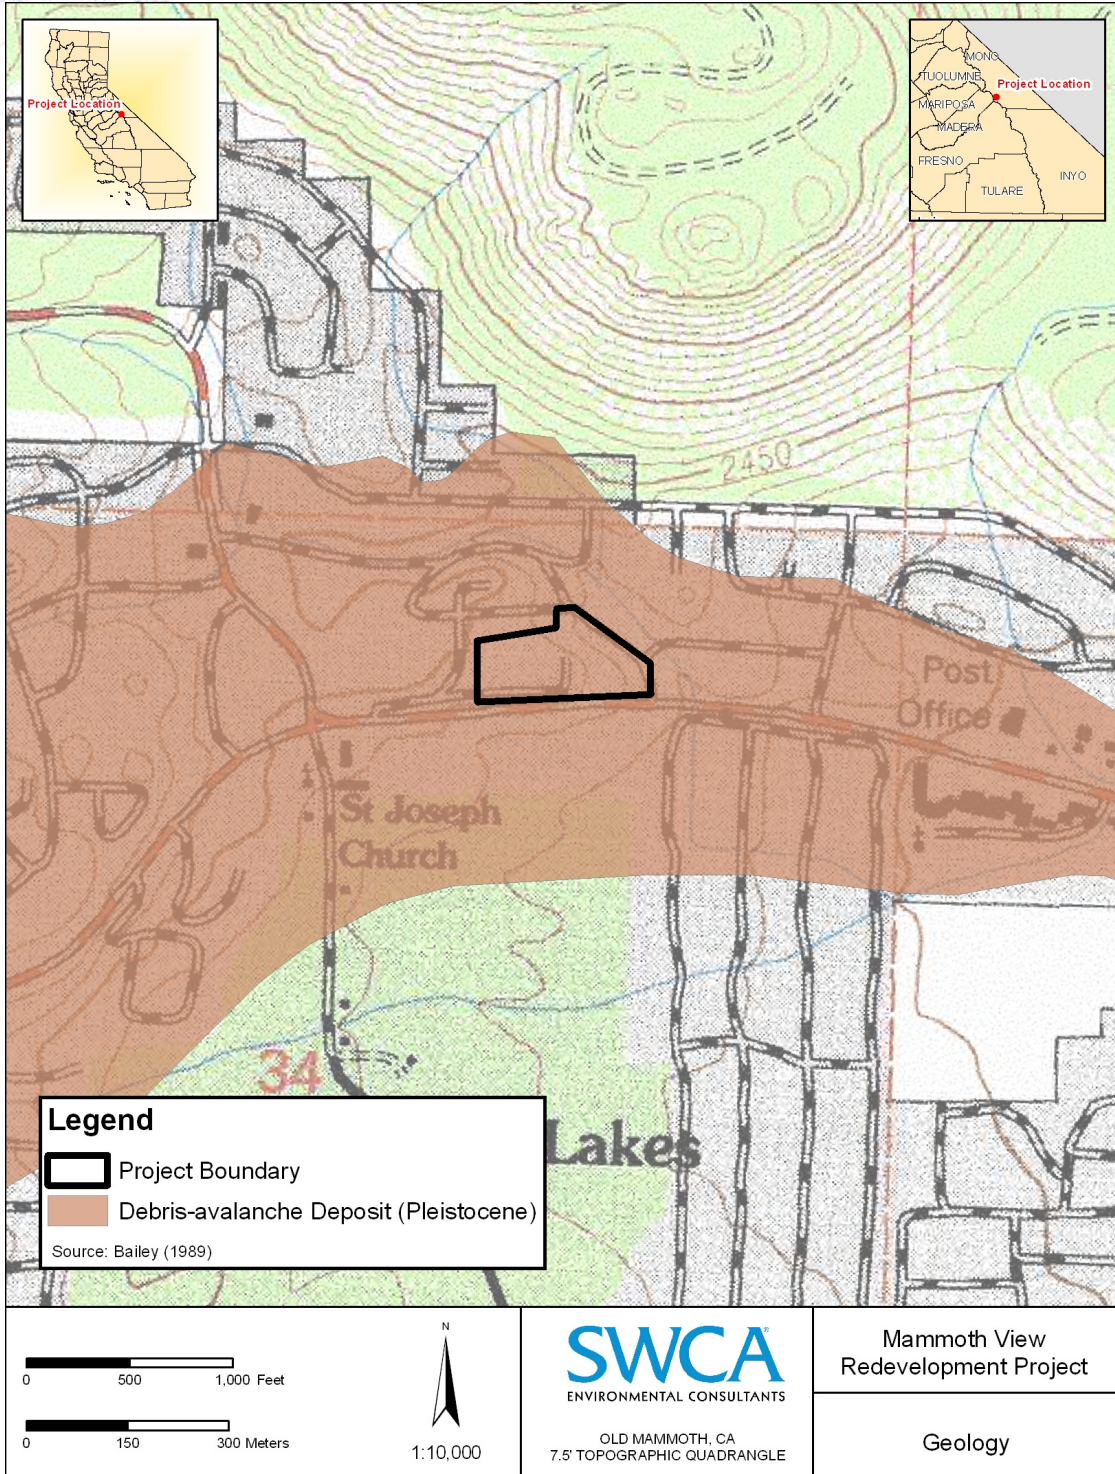
**Figure 2. Geologic Map**

The lithologic composition of the debris-avalanche deposits within the project area is not conducive to the preservation of intact fossils and is unlikely to yield scientifically significant vertebrate specimens. The underlying volcanic rocks are also not likely to contain vertebrate fossils, as most volcanic rocks are not generally suitable for the preservation of fossils due to their molten origin. The combined results of the museum records search and literature review suggest that the paleontological resources potential (sensitivity) for Pleistocene-age deposits and volcanic rocks within the project area is low.

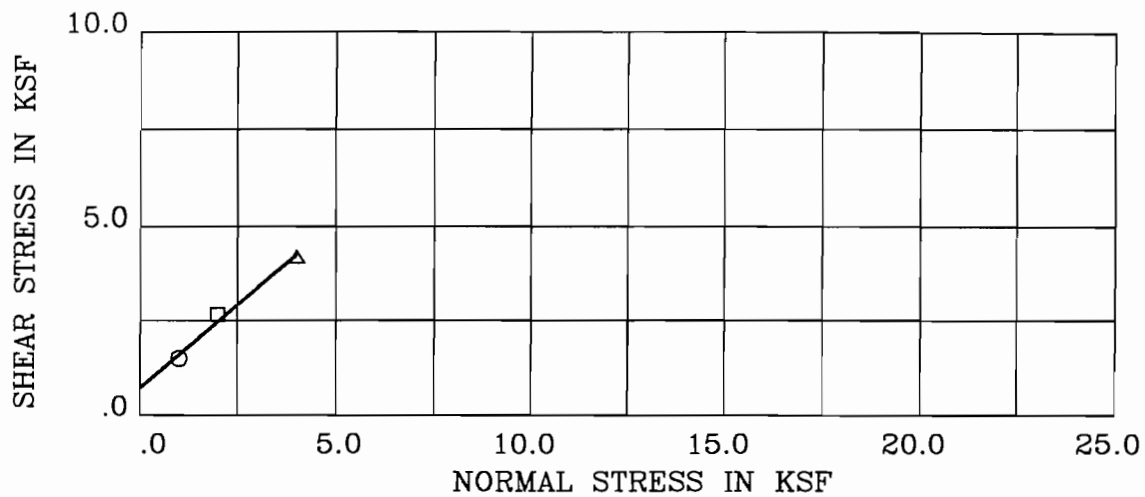
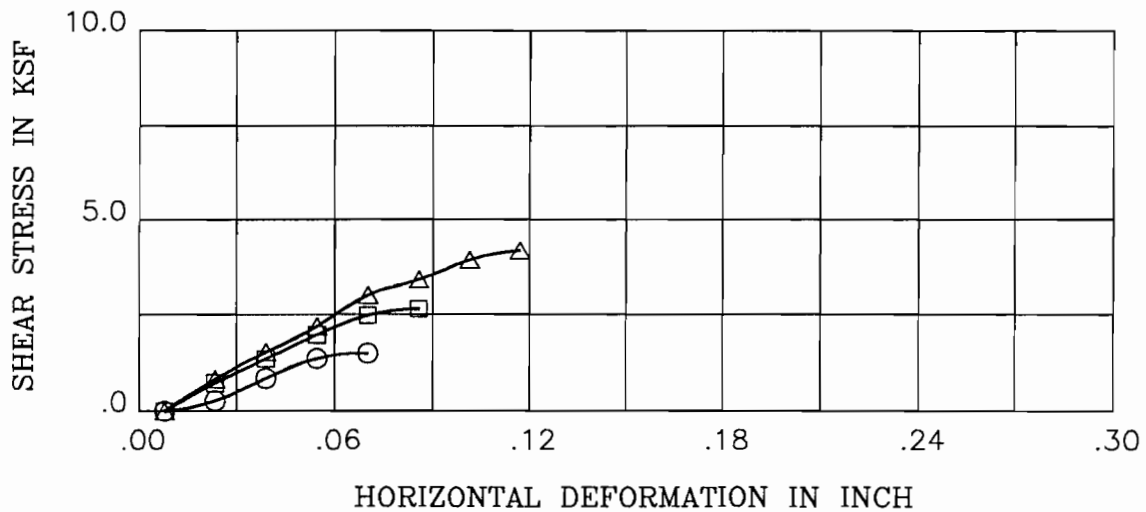
DIRECT SHEAR TEST Plate No. 3

BORING/SAMPLE : B-1 DEPTH (ft) : 21'-25' *722*  
 DESCRIPTION : WELL-GRADED SAND (SW)  
 STRENGTH INTERCEPT (C) : .717 KSF  
 FRICTION ANGLE (PHI) : 41.5 DEG (PEAK STRENGTH)

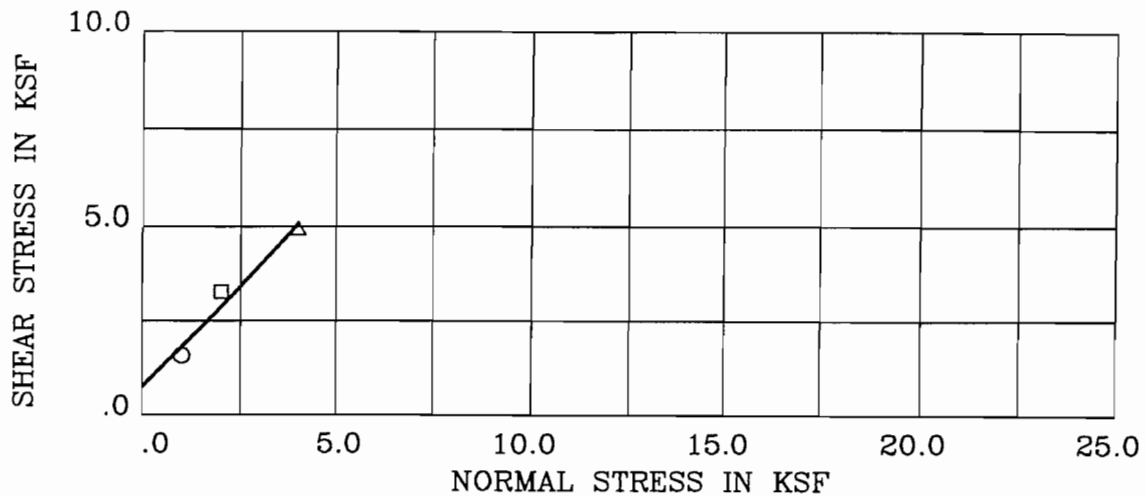
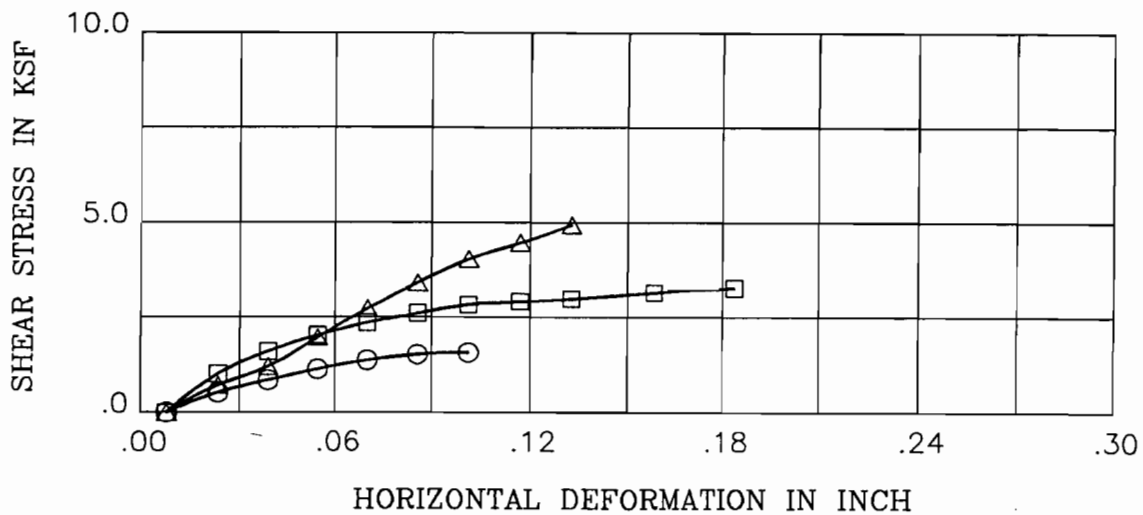
Plate No. 4

BORING/SAMPLE : B-2 DEPTH (ft) : 26'  
 DESCRIPTION : SILTY SAND (SM)  
 STRENGTH INTERCEPT (C) : .730 KSF  
 FRICTION ANGLE (PHI) : 47.3 DEG (PEAK STRENGTH)

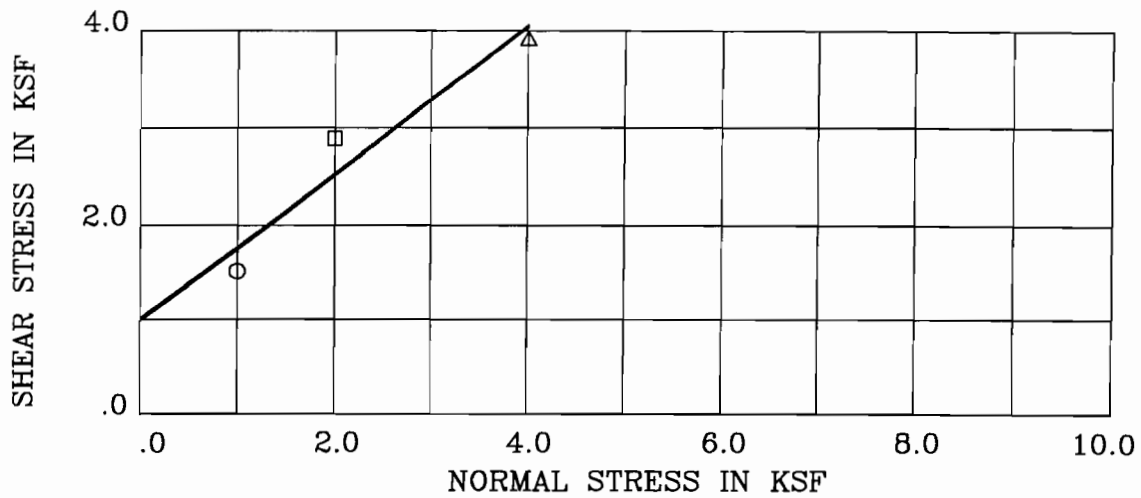
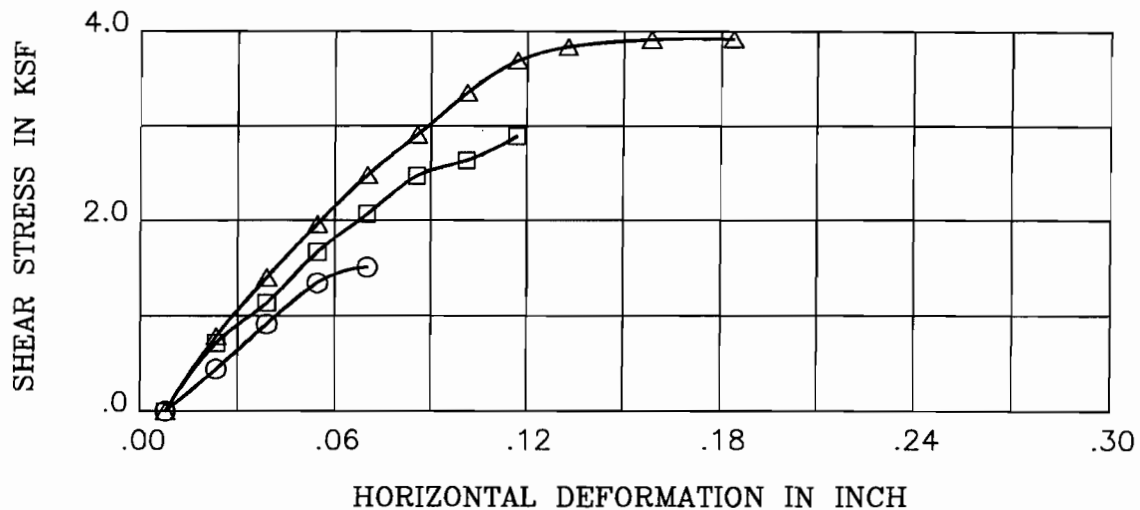
| Soils<br>Engineering<br>Inc | DIRECT SHEAR TEST | Plate No. 5 |

BORING/SAMPLE : B-1 DEPTH (ft) : 11'  
 DESCRIPTION : WELL-GRADED SAND (SW)  
 STRENGTH INTERCEPT (C) : .994 KSF (PEAK STRENGTH)  
 FRICTION ANGLE (PHI) : 37.3 DEG

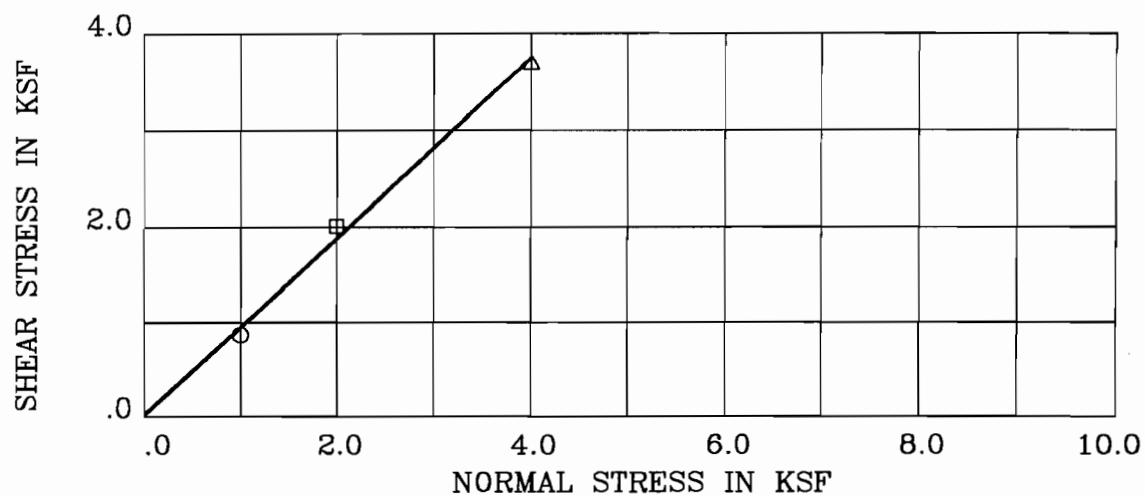
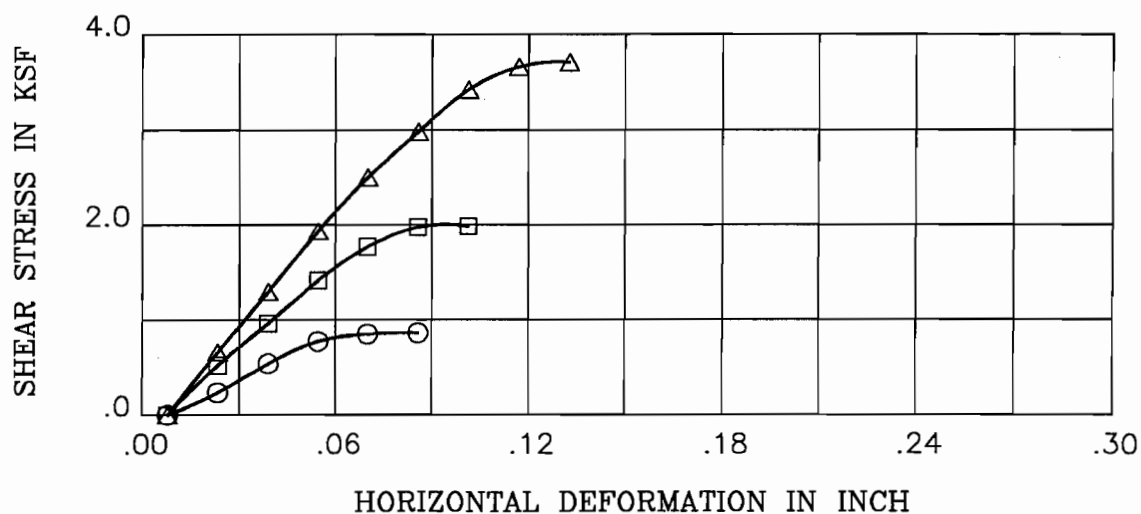
| Soils Engineering Inc | DIRECT SHEAR TEST Plate No. 6 |

BORING/SAMPLE : B-2                      DEPTH (ft) : 6'  
 DESCRIPTION : WELL-GRADED SAND (SW)  
 STRENGTH INTERCEPT (C) : .014 KSF  
 FRICTION ANGLE (PHI) : 43.0 DEG                      (PEAK STRENGTH)

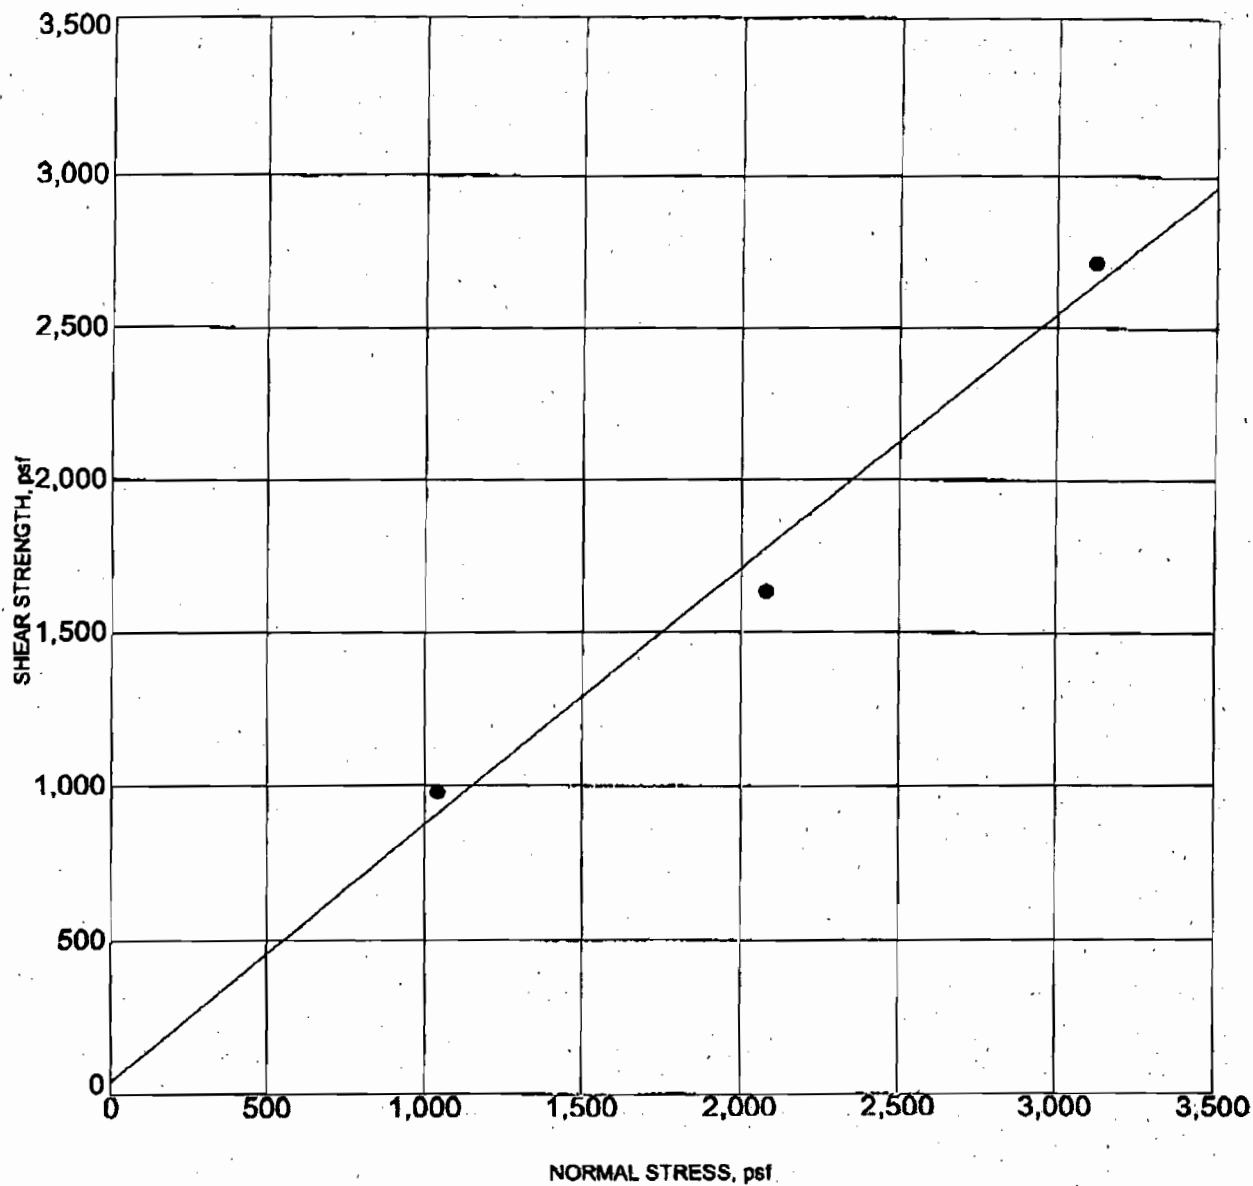
**DIRECT SHEAR DIAGRAM**

Boring No.: TP#2

Friction Angle: 40 degrees

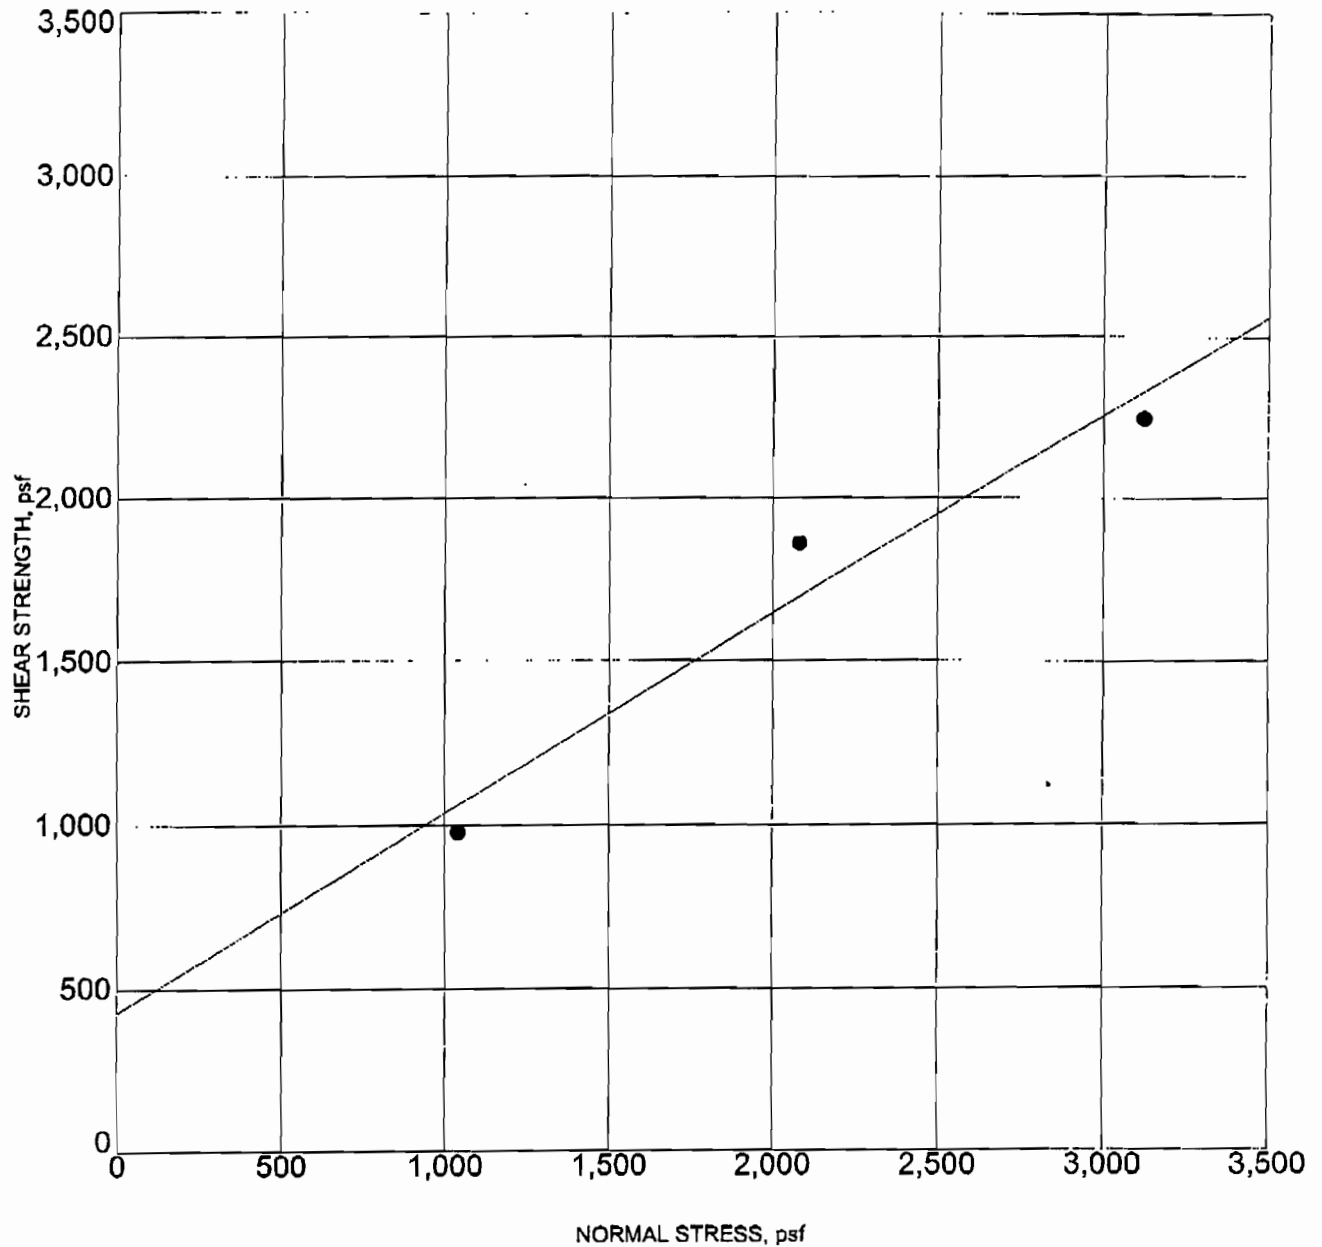
**DIRECT SHEAR DIAGRAM**

Boring No.: TP#7

Friction Angle: 31 degrees

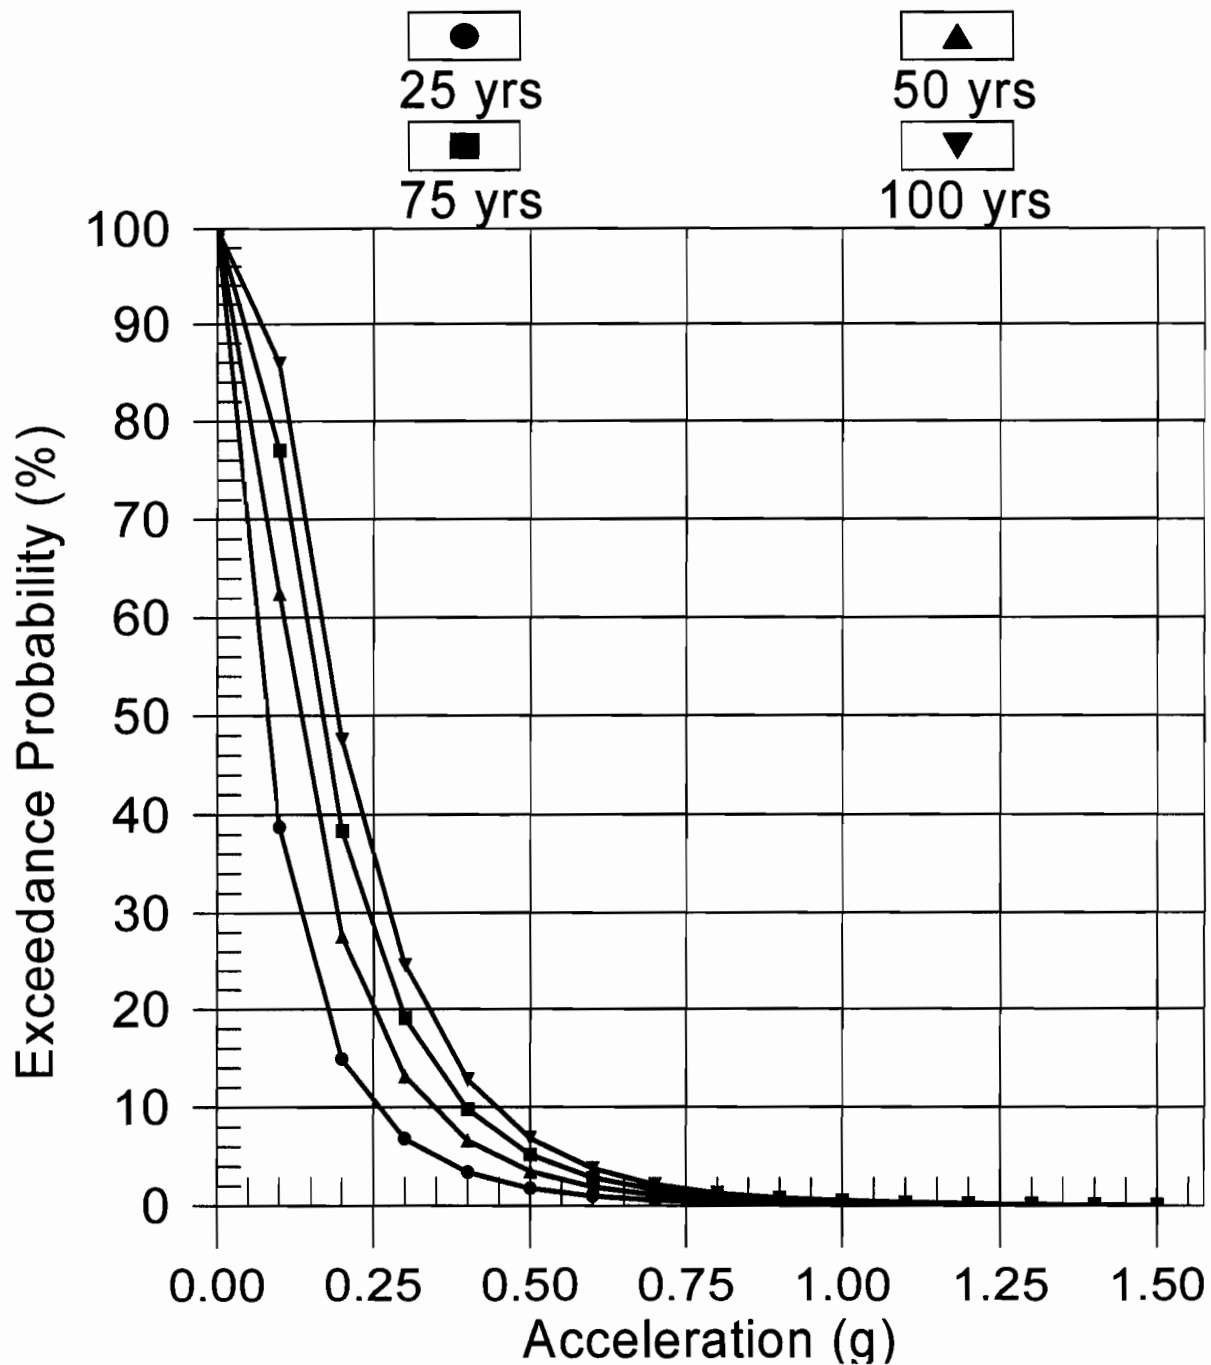
# PROBABILITY OF EXCEEDANCE

BOORE ET AL(1997) NEHRP C (520)1

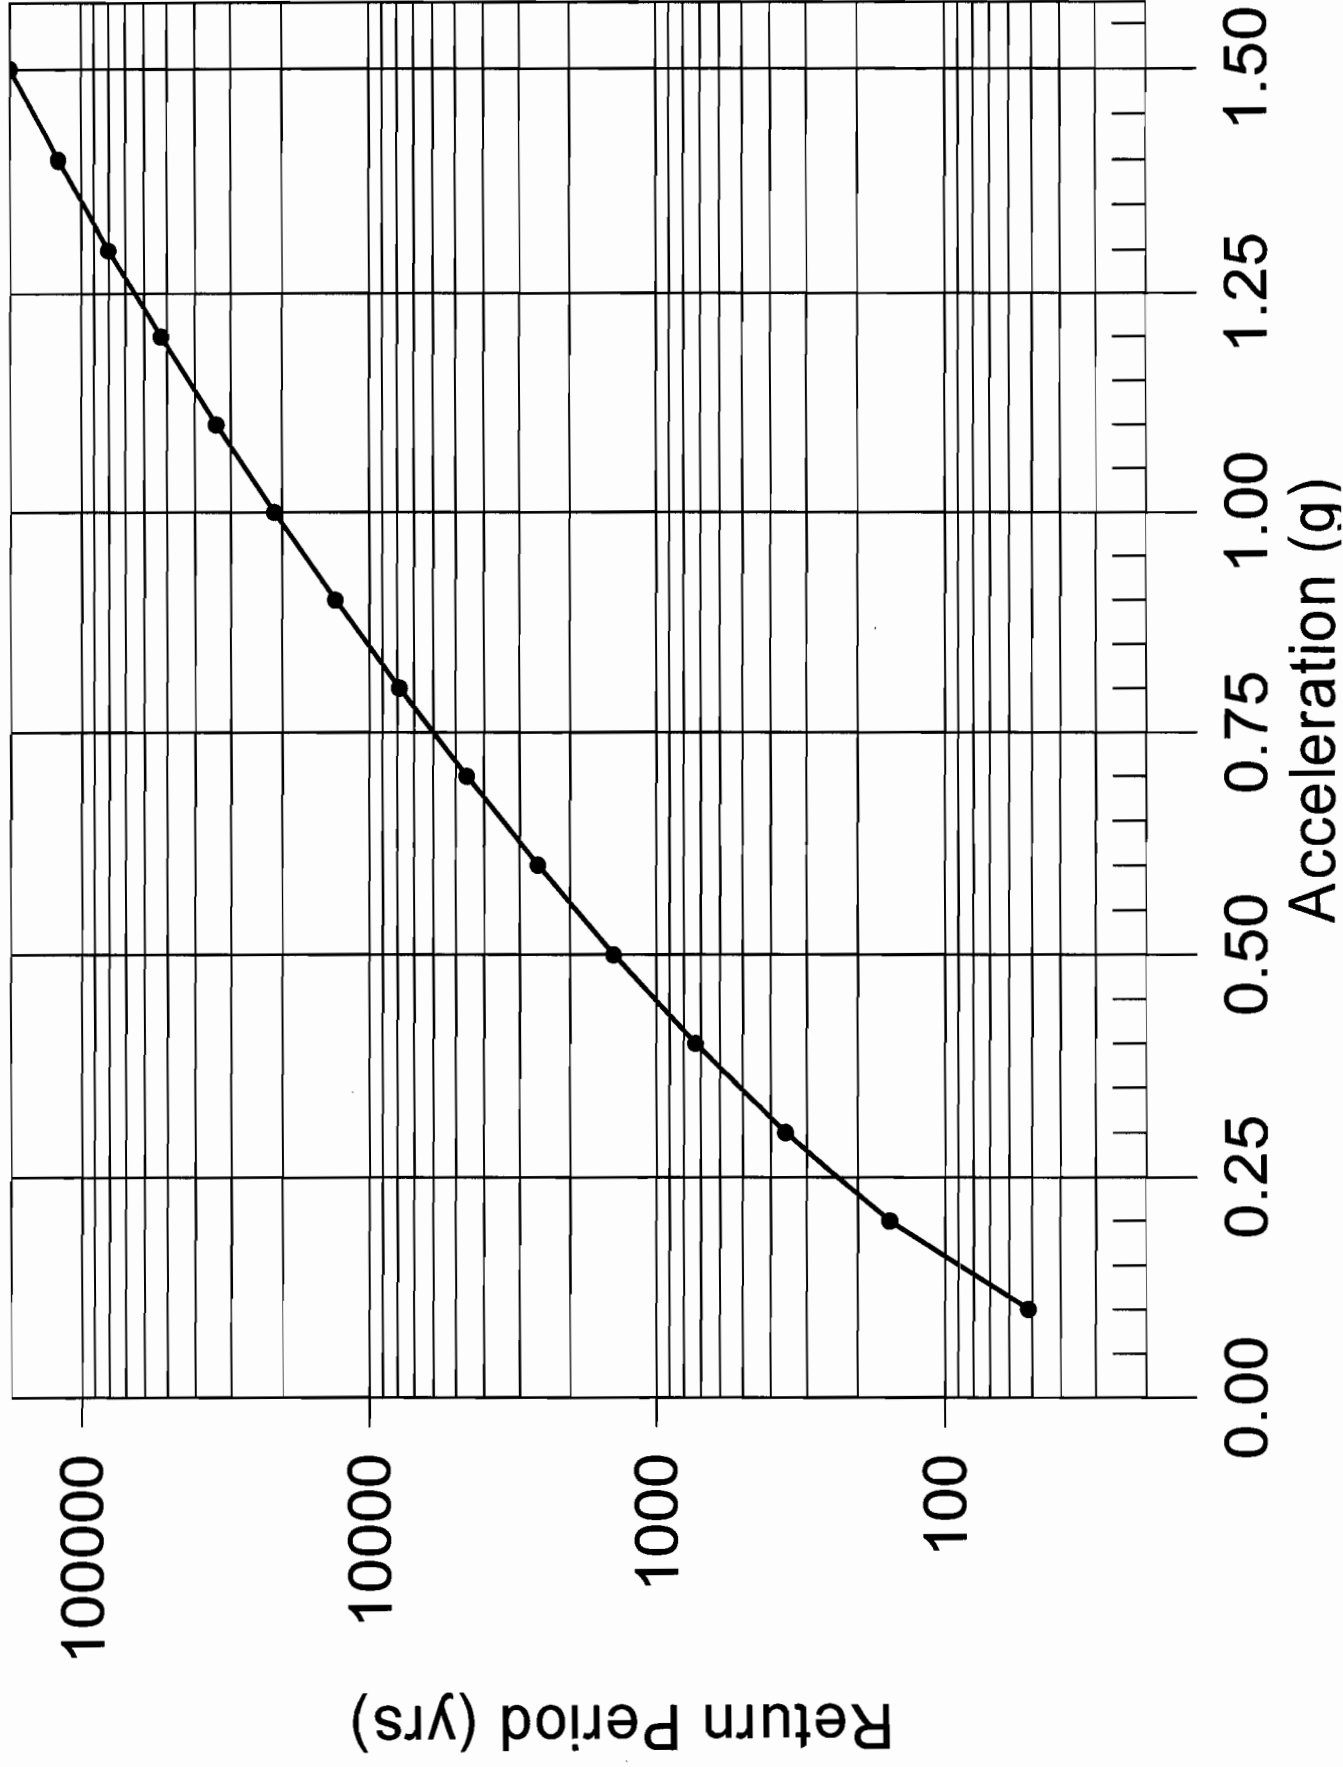
# RETURN PERIOD vs. ACCELERATION

## BOORE ET AL(1997) NEHRP C (520)1
